ORNL/RAP/LTR-86/8

DATE: January 1986

SUBJECT: Identification of Low-Level Waste Line Leak Sites  
at Oak Ridge National Laboratory

5. IDENTIFICATION OF LOW-LEVEL WASTE LINE LEAK SITES  
AT OAK RIDGE NATIONAL LABORATORY

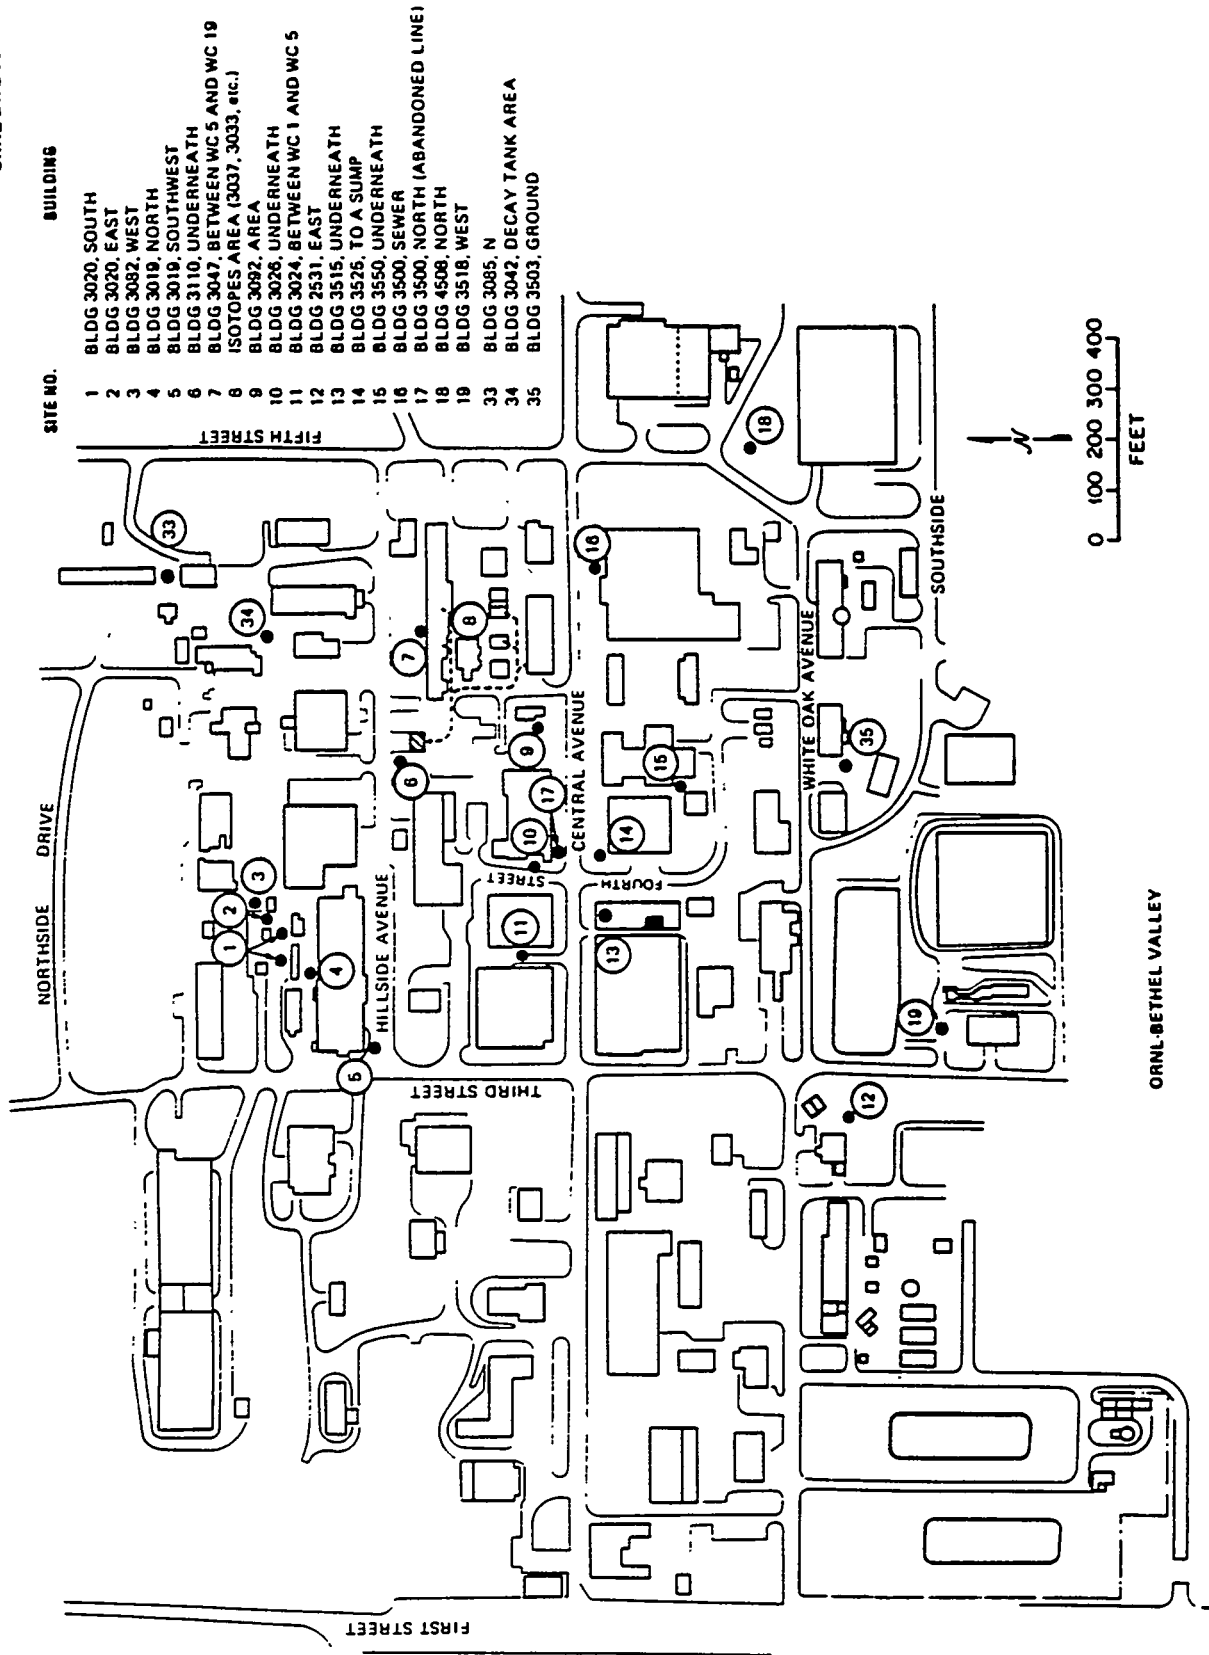
Figure 4. Location of LLW Leak Sites in the ORNL Main Complex.

Twenty-three of the leak sites are within ORNL's main complex with 20 of the 23 sites being concentrated in the 3000 and 3500 blocks which are divided by Central Avenue (Fig. 4). The contamination is predominantly subsurface; however, surface contamination has occurred in some cases. Contamination has been reported underneath Buildings 3047, 3026, 3515, and 3550, and there is a high probability of contamination under other buildings in the General Isotopes area. Contamination is frequently due to leaks around transfer line and tank junctions where in some cases contamination has been detected as much as 20 feet below grade. Much of the sanitary sewer contamination, listed as site 16, results from crossovers to the system from areas of LLW line leaks and spills in the main area.

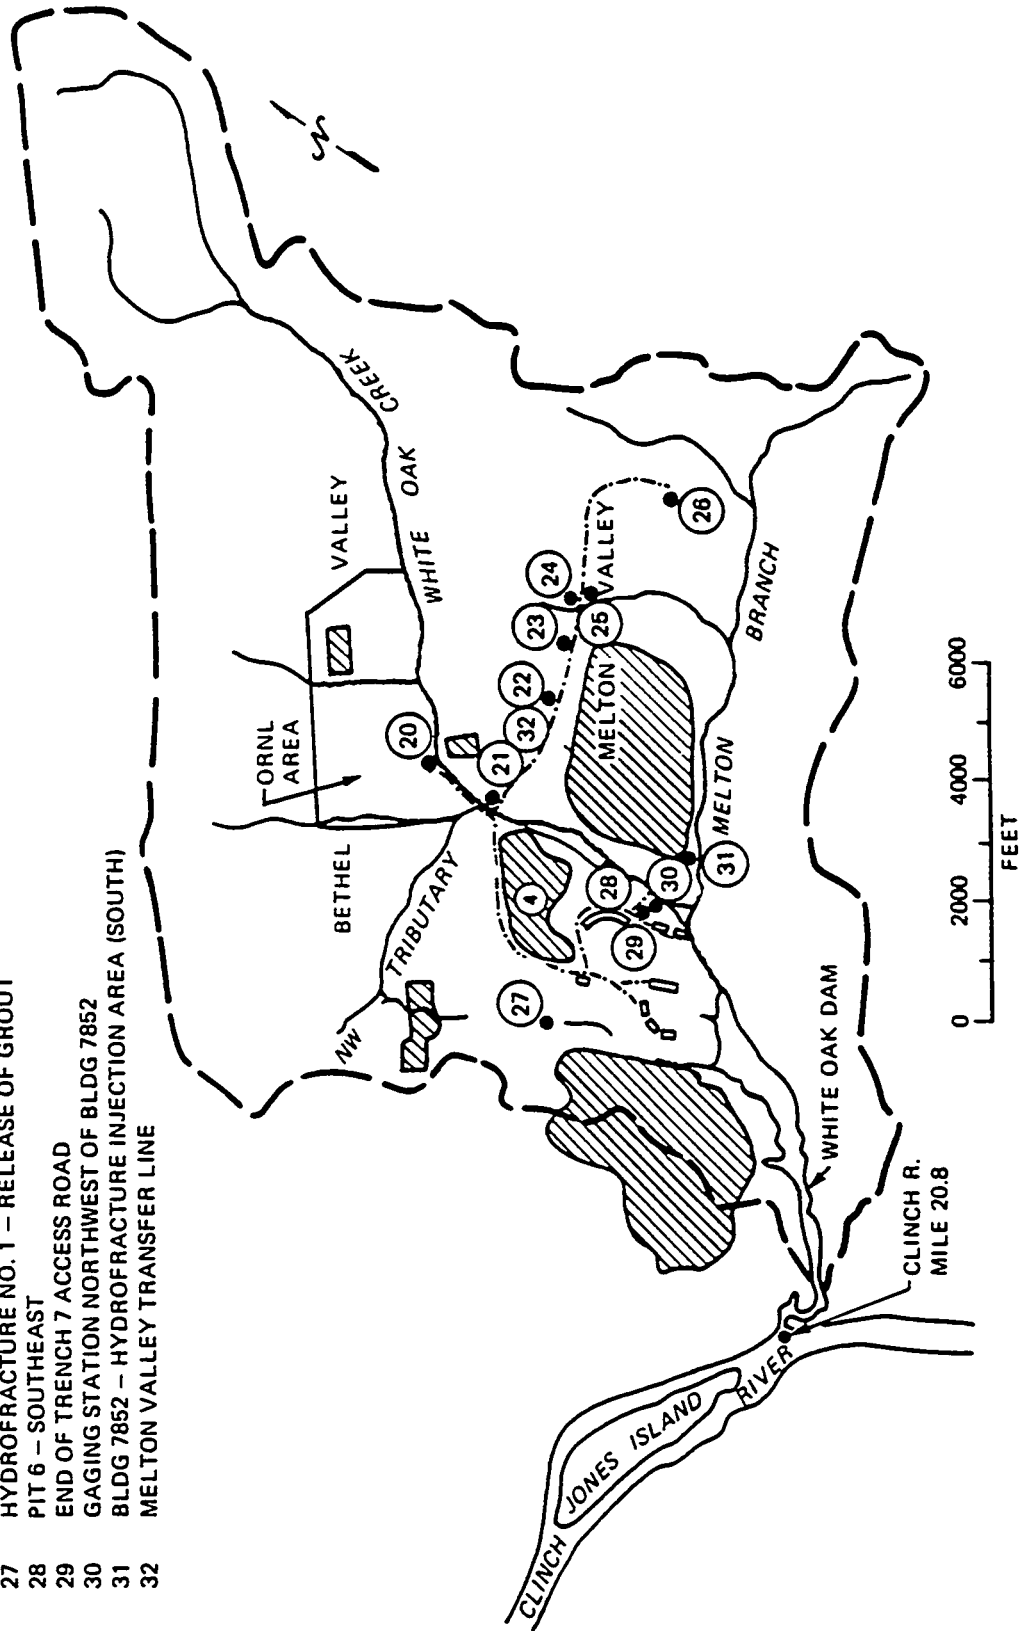
Figure 5. Location of LLW Leak Sites in Melton Valley.

The leaks and spills in the Melton Valley area of ORNL are generally along either the ILW or Melton Valley Transfer Line, with isolated incidents occurring during hydrofracture operations. Many of the Melton Valley, as well as the Bethel Valley, sites are located near other Remedial Action Program sites.

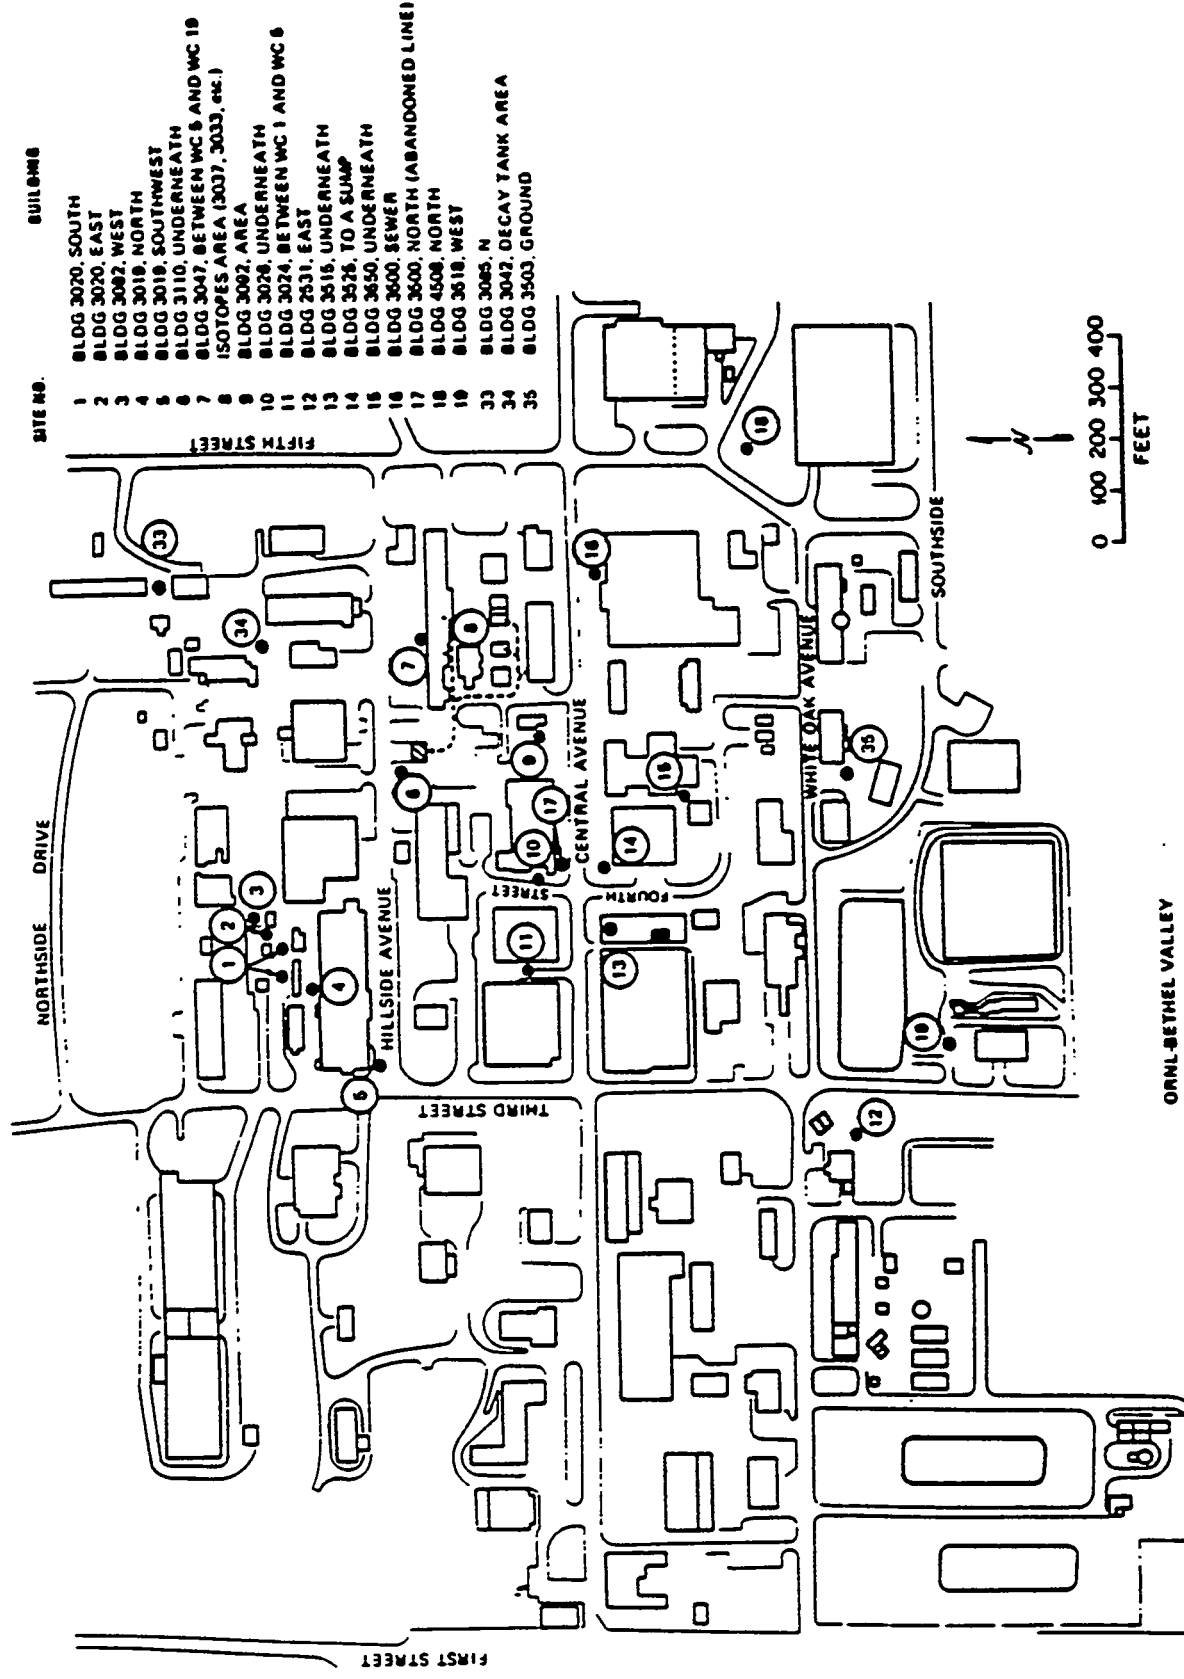
Figure 1. Location of LLW Leak Sites in the ORNL Main Complex.

Group 2 consists of sites 6 through 11, 33, and 34 and is the General Isotopes Area in the ORNL main complex (see Fig. 1). The area is located near Central Avenue. The buildings used as reference location for leak sites located in this area include:

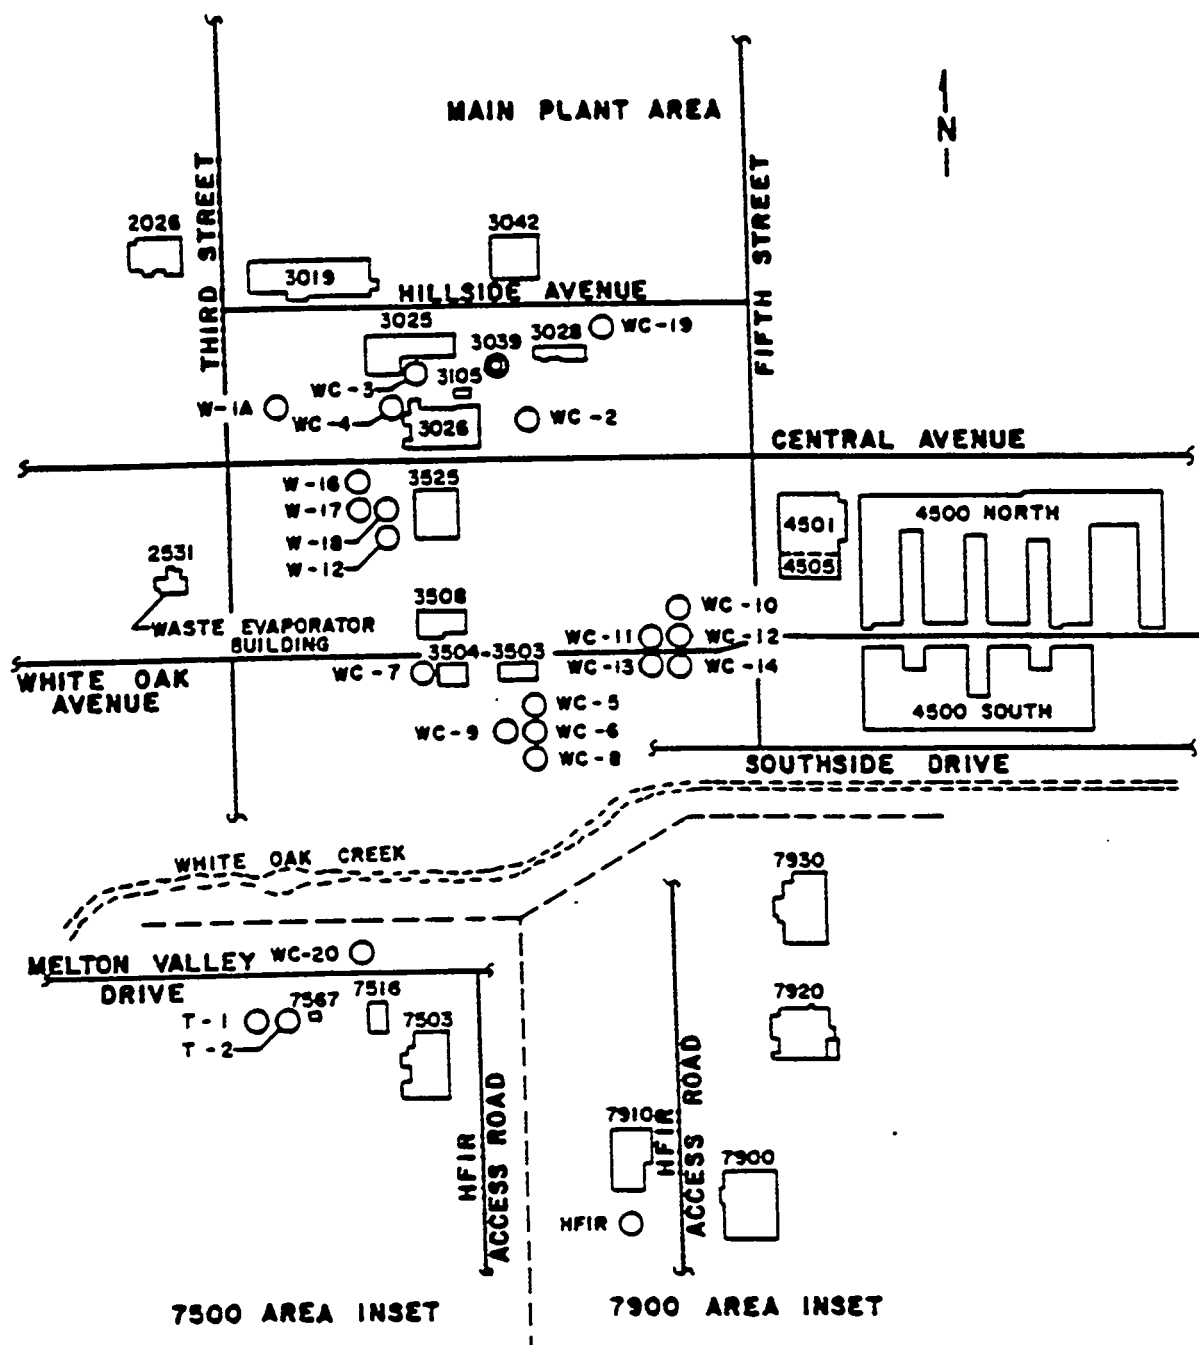
Figure 2. Map showing the location of the LLW Collection Tanks.<sup>18</sup>  
(Not to scale)

This site was included in a tabulation of contaminated areas dated January 31, 1972 and keyed to engineering drawing A-90015-0-0063-F Rev(0). The site was reported as a break in the transfer line between WC-1 and WC-5. Excerpts from Operations Division Reports reporting leaks from various tanks in this area and contributors to contamination in this area are included below. Figure 2 is provided to show the location of the various LLW collection tanks in the main plant complex.

A new gasket was placed in the connecting flange to the outlet valve from tank W-1, and the connecting flanges to the outlet tank W-2 were tightened. Leaks had been found at these places, which were undoubtedly contributing to the high activity discharged from the retention pond.<sup>17</sup> (November 1952)

A large leak was again found at the flange of the W-1 tank outlet valve. A new gasket was installed in this flange last month, but it failed to hold because the wrong size had been

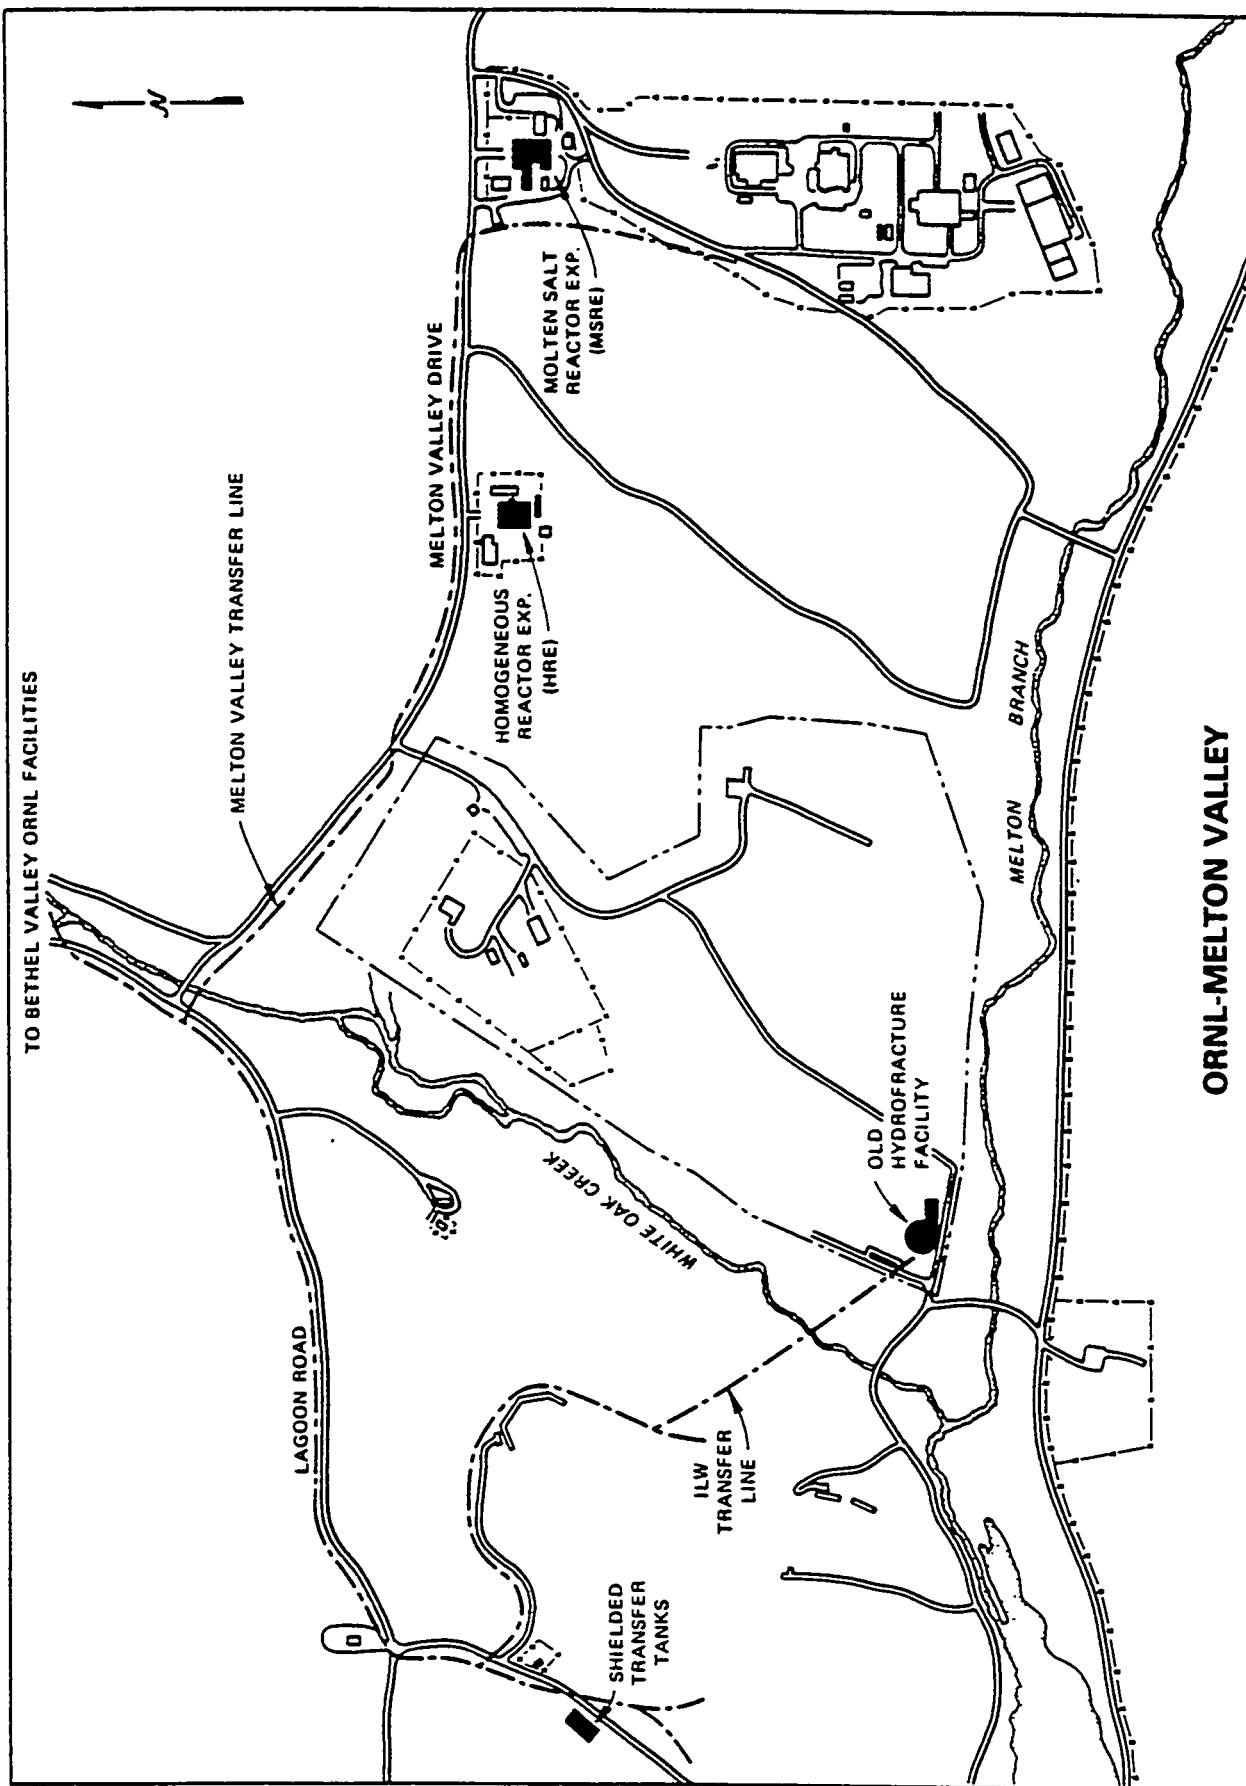
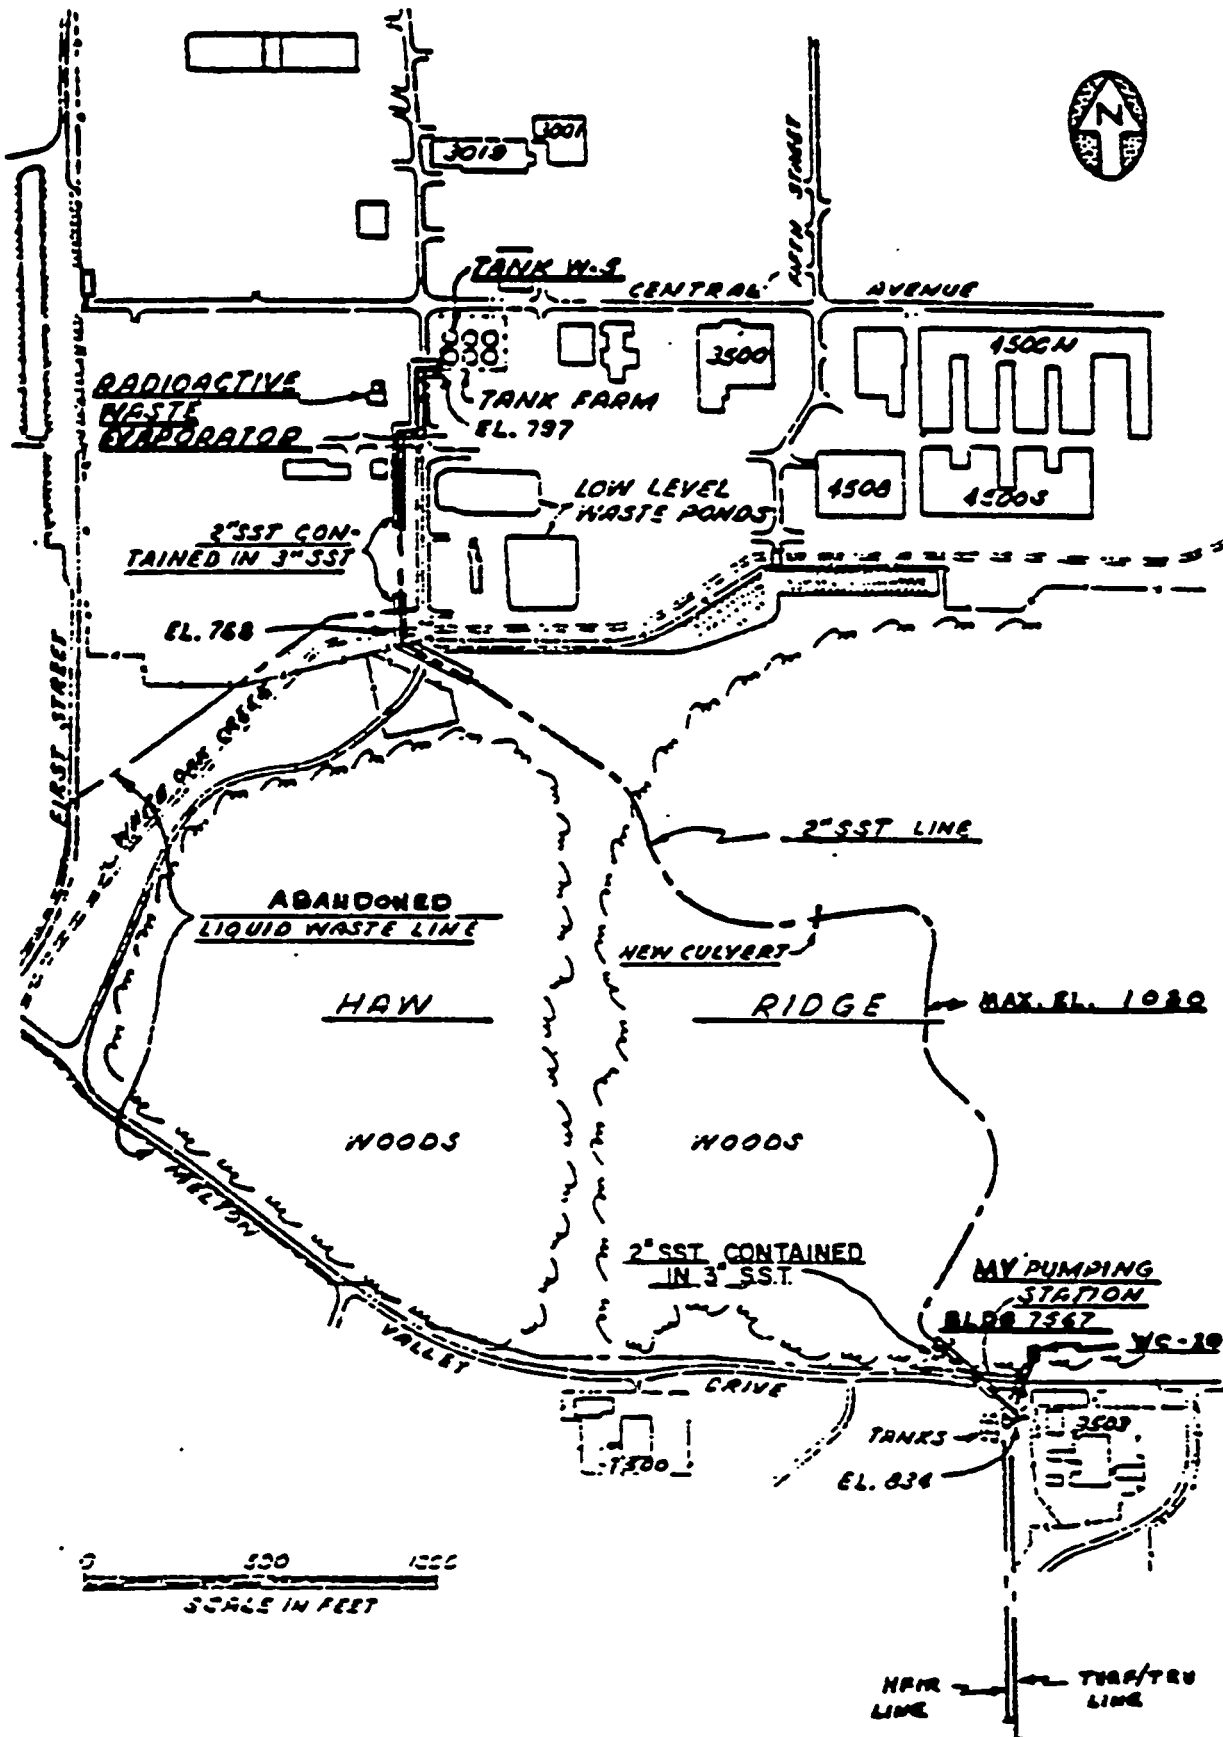
Figures 5 and 6 show the pipeline system in this area.

Figure 5. LLW (ILW) and Melton Valley Transfer Lines

Figure 6. Transfer Line from Melton Valley Pumping Station. <sup>18</sup>

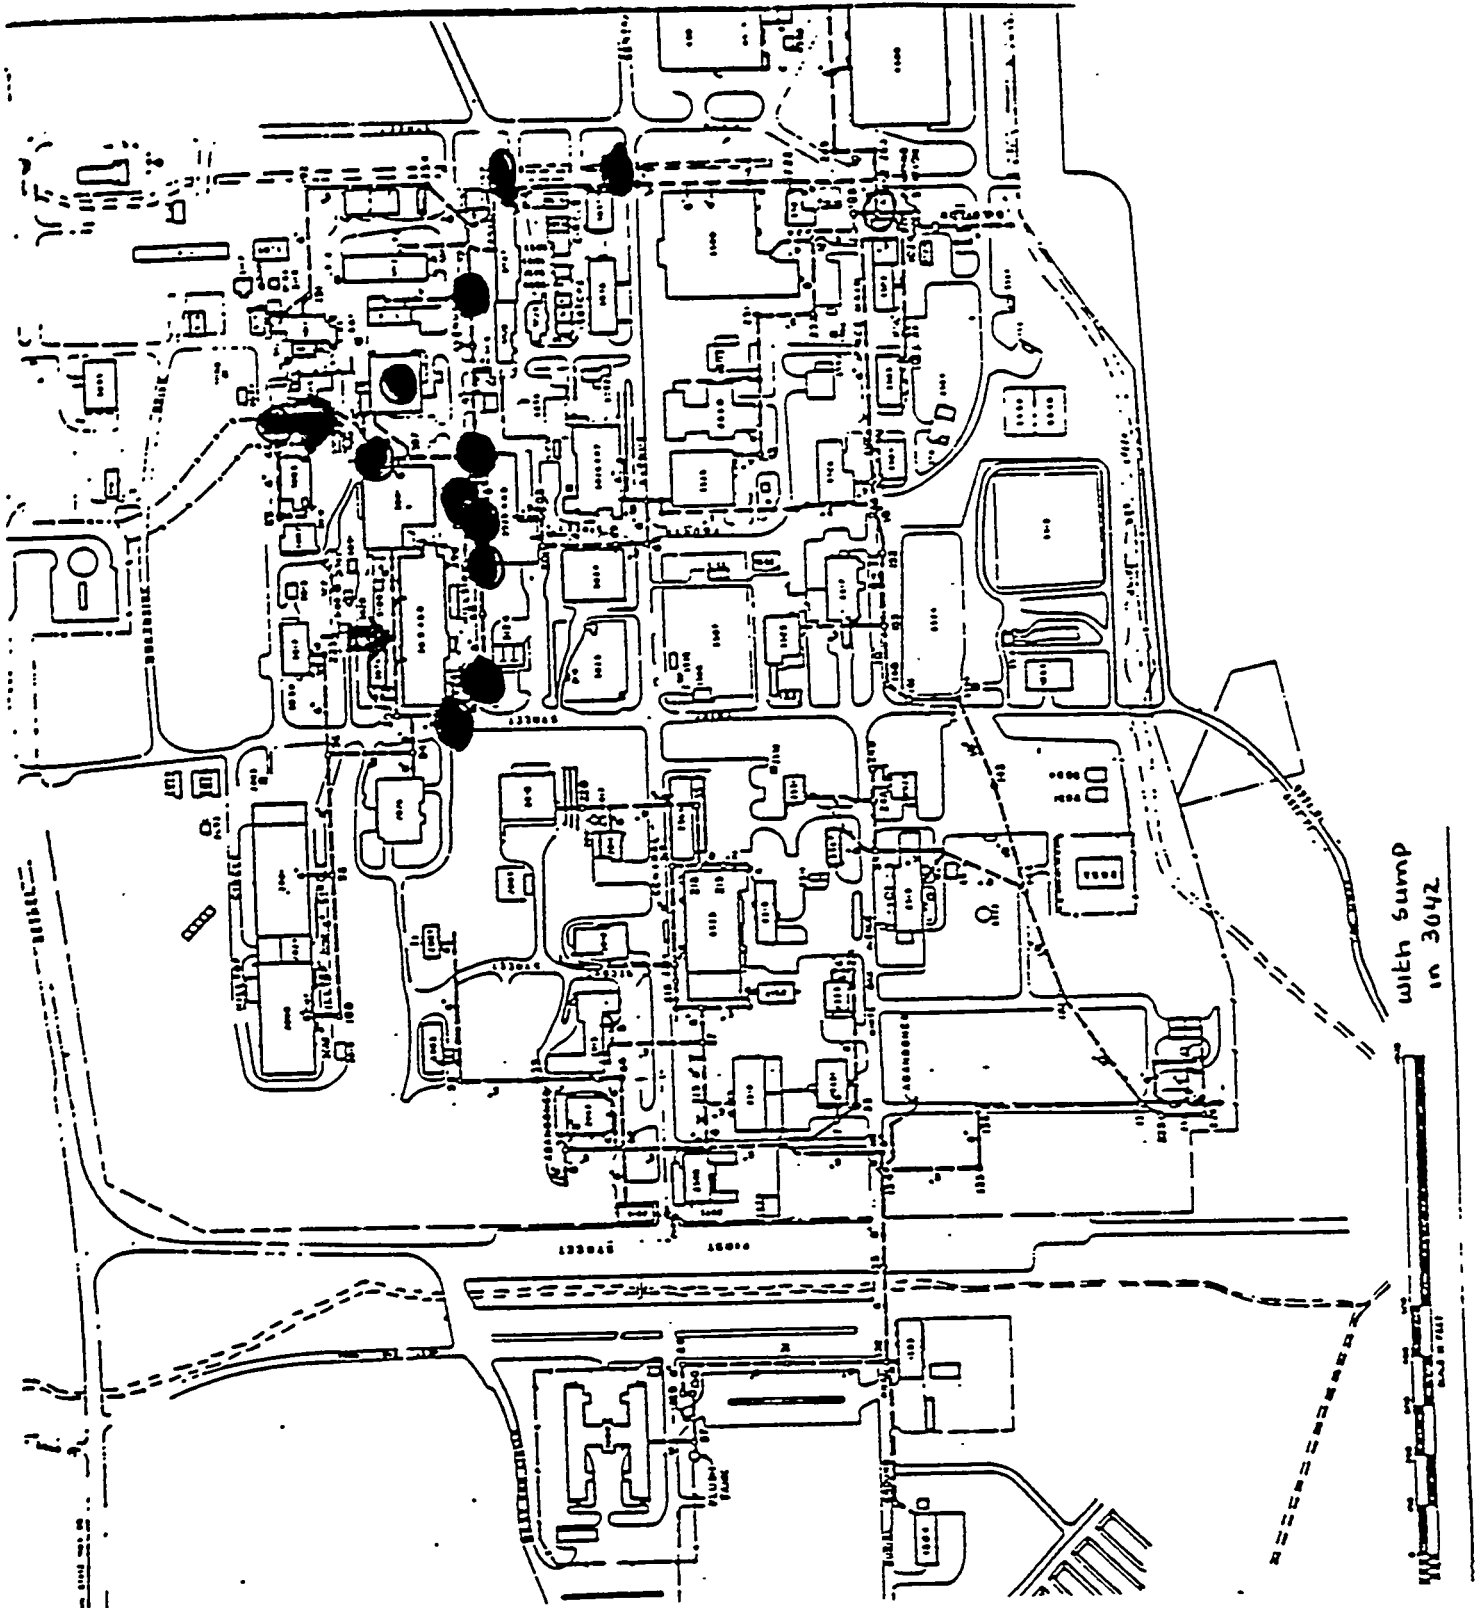
Figure 1. Planning Map  
Oak Ridge National Laboratory  
Bethel Valley  
Sanitary Sewer System

7. Sites where dye was found in the sanitary sewers, creek, and storm drains. Circles are proportional to the amount detected.
8. Amount of dye found at the ORR sump during each test period (inner sump).

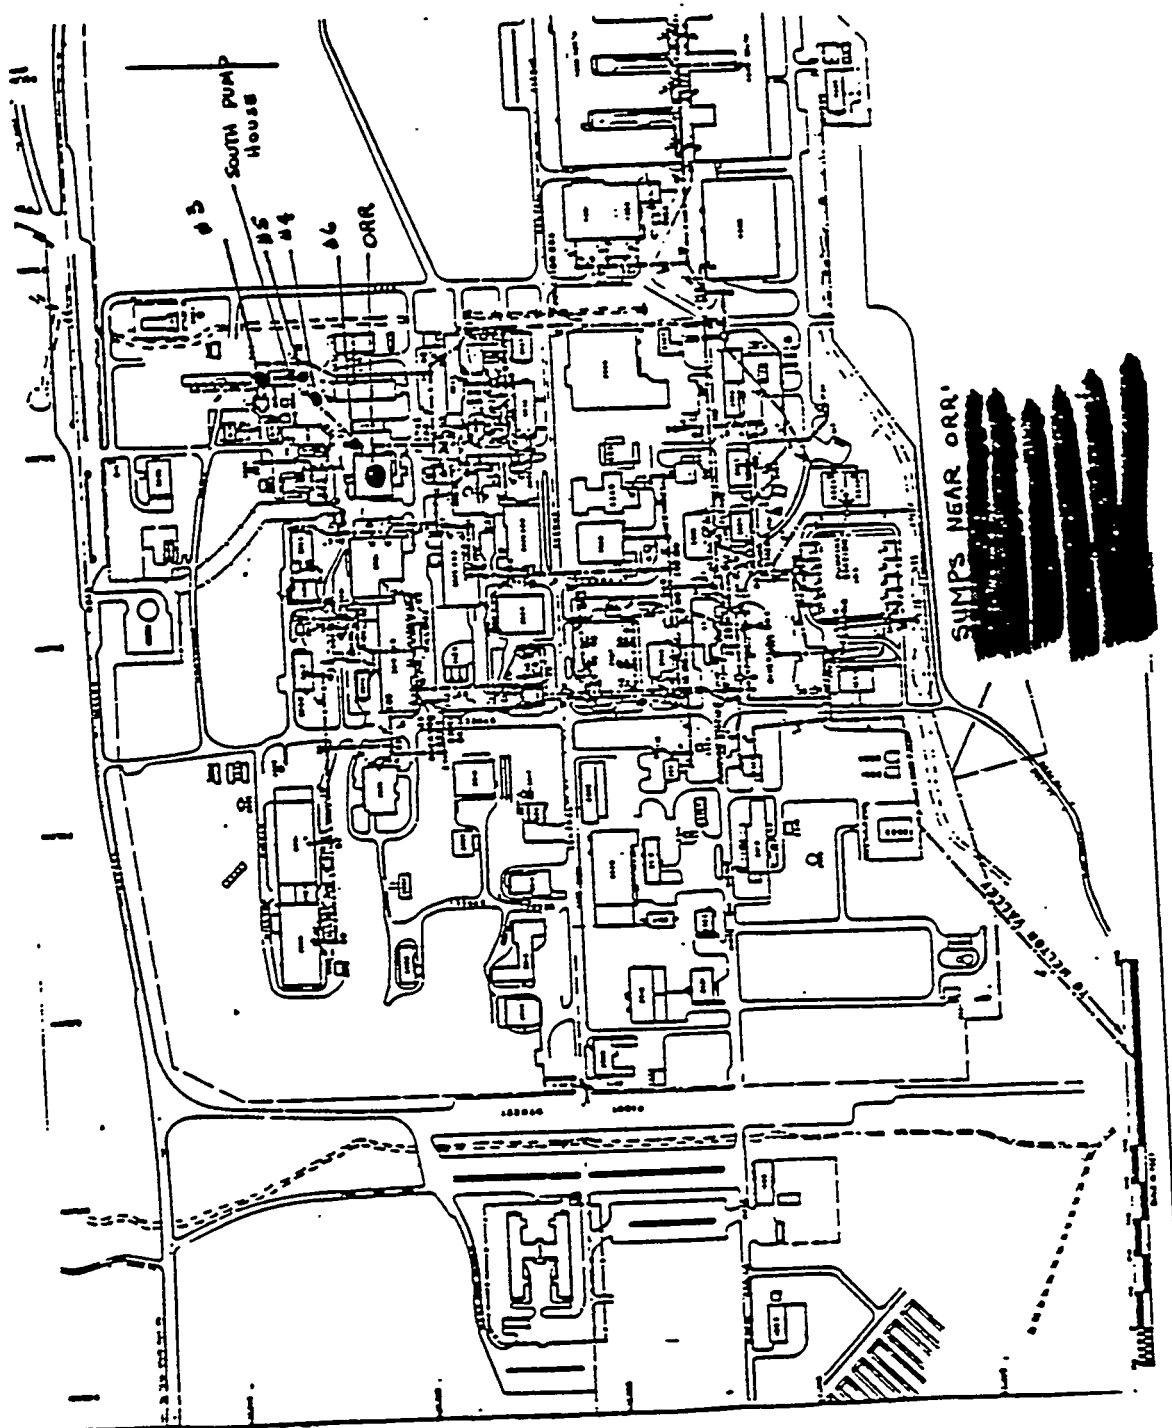
Figure 10. Sumps and Elevations

9. Amount of dye in outer (process waste) sump at ORR during each test interval.
10. Locations and bottom elevations of sumps used for groundwater control near the ORR.
